## The Effect of Reflected Blast Waves in HDPE Mortars

K. L. Kosanke and L. T. Weinman

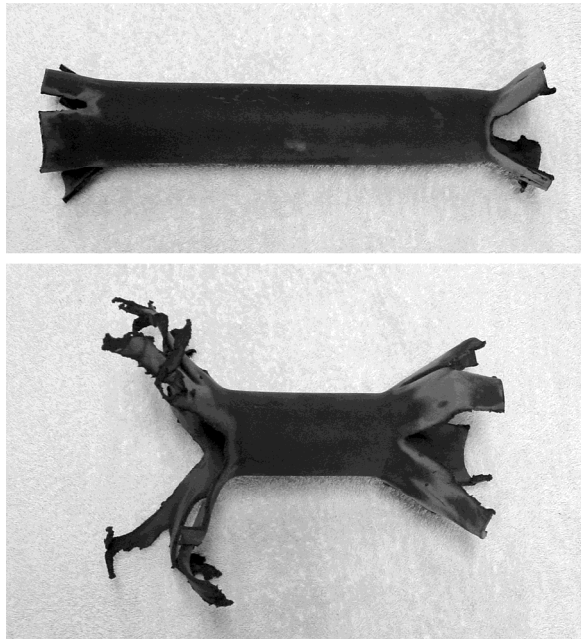
In the next pair of tests, 2-inch HDPE mortars were subjected to explosive blasts. During the course of a fireworks display a powerful explosive blast inside a mortar might potentially originate from a premature functioning of a star shell or a salute. In these tests, the pressure events were produced using flash powder charges contained in thin-walled polyethylene bottles that were of only slightly smaller diameter than the inside diameter of the mortars. Each test charge was suspended just inside the mortar near its muzzle. The results of the two tests are shown in Figure 3. In one test a charge mass of only 25 grams of flash powder was used (upper mortar in Figure 3), and in another test a charge of 50 grams was used (lower mortar in Figure 3). With the smaller flash powder charge most of the mortar is undamaged, except for its two ends, which are damaged almost equally. In the photograph, the left end of the mortar is the muzzle of the mortar (nearest the explosive charge) and the right end is where the plug had

been. With the larger explosive charge, the damage is more extreme but is still concentrated at the two ends of the mortar. Thus the reflected blast wave prediction was fully borne out in these tests.

Figure 3. Photographs of the two mortars tested using small explosive charges.
