Further Report on the Testing of Suspect Tiger-Tail Comets

K. L. and B. J. Kosanke

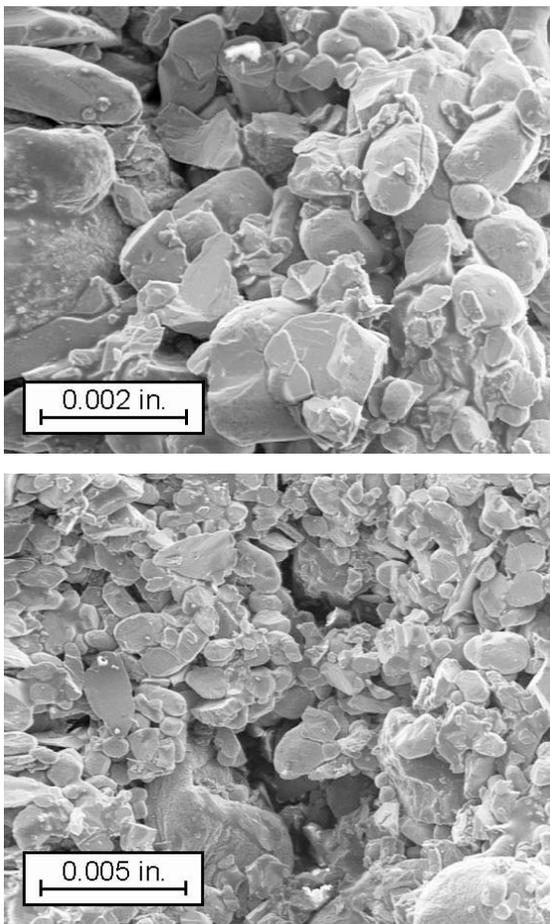
Calculated from the size and mass of the comet, its bulk density was approximately 1.5 g/cm^3 . Based on its apparent formulation, the maximum theoretical density of the comet composition is approximately 2.5 g/cm^3 . This difference corresponds to a porosity of approximately 40%, whereas a porosity of roughly 20% is more typical for well-compacted pyrotechnic compositions. The particularly high porosity was confirmed through a microscopic examination, which suggested that gas permeability would also be high. Figure 1 contains two electron micrographs of the comet composition. The upper micrograph demonstrates the extent to which there tends to be void spaces between individual particles in the comet, which themselves appear somewhat like a collection of boulders in a loose pile. The lower

micrograph (taken at lower magnification) is similar in appearance but also documents the occurrence of larger more cavernous voids in the composition.

Figure 1. Electron micrographs of the problematic comets.

they share characteristics that are thought to have been the cause of the malfunctions. Both types of comets combine a high energy oxidizer (potassium perchlorate) with small particle size magnesium (in effect constituting somewhat compacted and bound flash powder). Both types of comets have internal structures thought to produce a relatively high degree of gas permeability (fire paths that allow the rapid spread of combustion). The combination of these characteristics is thought to allow the near instantaneous release of large amounts of pyrotechnic energy, occasionally manifesting itself as a powerful explosion. What makes these malfunctions especially problematic is that they are occurring in items generally thought not to be capable of exploding at all.
