Another Example of Explosively Malfunctioning Comets^[1]

K. L. and B. J. Kosanke

This article reports on another batch of comets, imported from China, that tend to malfunction by exploding violently within their mortars as they are being fired. In the last few years, the authors have reported on imported Chinese comets from two other manufacturers, with somewhat similar construction characteristics, that also tended to explode violently upon their firing.^[2-6] In each case, it was found that the malfunctioning white (or silver) comets had a high percentage of very fine magnalium (magnesium–aluminum alloy), used potassium perchlorate as the oxidizer, and had internal voids that could function as fire paths.

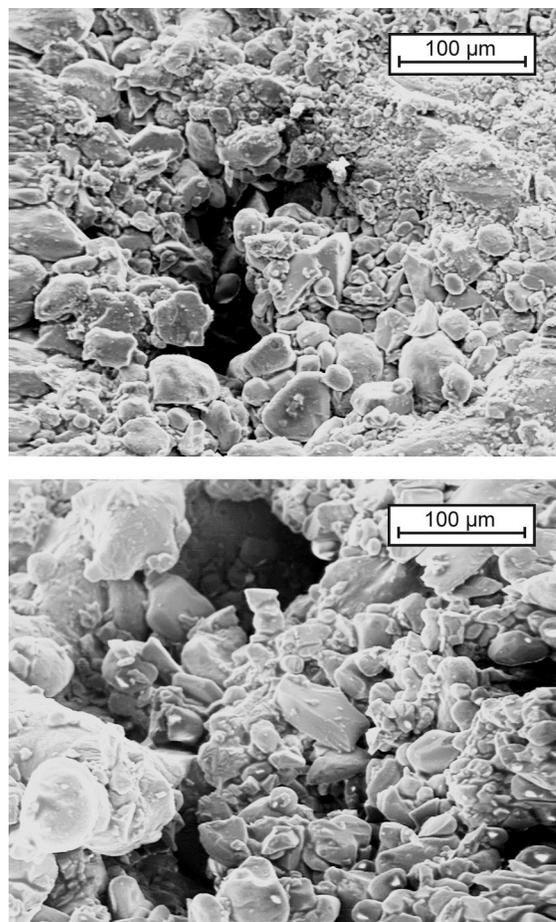
Small solid pieces to comet composition were taken from comets from the two groups (those apparently well behaved and those tending to explosively malfunction). These samples were mounted and sputter coated with gold in preparation for inspection using a scanning electron microscope. Figure 1 presents a pair of images of the typical internal structure of the two types of comet samples. The pieces of composition from the apparently well-behaved comets (see the upper micrograph in Figure 1) were found to have the appearance of being somewhat loosely bound and occasionally had fairly large void spaces. In comparison, the pieces of composition from the occasionally malfunctioning comets (see the lower micrograph in Figure 1) have an even more loosely bound appearance and significantly more and larger void spaces.

Figure 1. A pair of electron micrographs (200X magnification) comparing the typical internal structure of comet samples from the apparently well-behaved comets (above) and those tending to explosively malfunction (below).
