Mortar Plug and Recoil Problems

K. L. and B. J. Kosanke

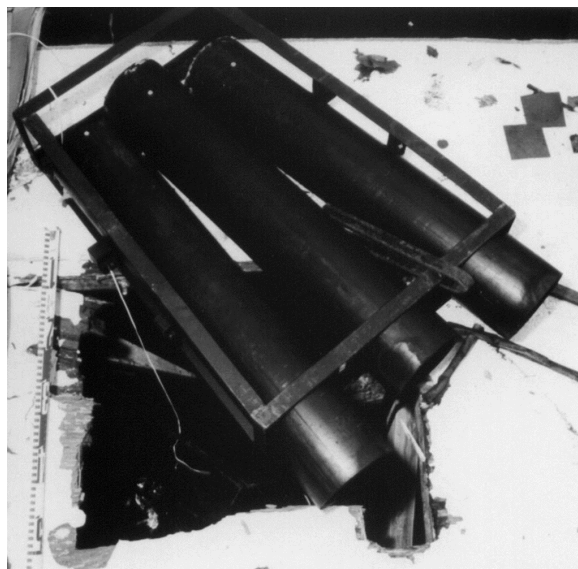
As part of a firework display, a volley of 4-inch double-break spherical aerial shells^[b] were to be fired from three racks positioned side by side. The shells were loaded into the company's normal mortars in their standard racks. These mortars and racks had been successfully used many times previously to fire single-break spherical shells of the same diameter. However, on this occasion, heavier and more powerfully-lifted double-break shells were being fired from the relatively weak and flexible deck of an old wooden barge. On this occasion, upon firing the shells, the mortars recoiled with enough collective force for the racks to break through the wooden deck of the barge (see Figures 1 and 2). In addition, most of the mortars blew (lost) their plugs (see Figure 3).

Figure 1. A photograph of deck of the wooden barge, with one of the three mortar racks partially covering the hole in the deck.

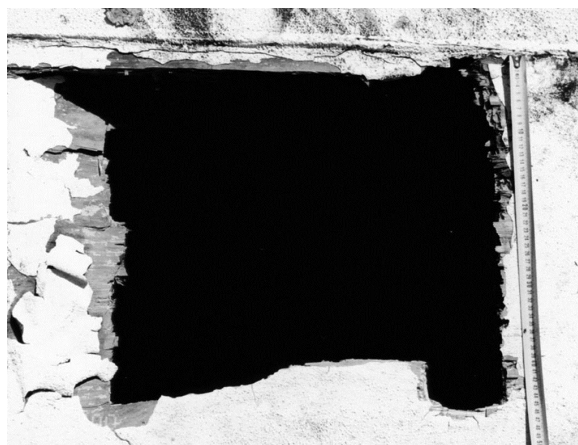
Figure 2. A photograph of the approximately 18-inch square hole in the deck of the wooden barge where the three mortar racks had broken completely through.

As regards the failure of the barge deck, it can reasonably be concluded that there were two factors that combined to produce the deck failure, one fairly obvious and one not so obvious. The fairly obvious factor is that the internal mortar pressures for double-break spherical shells are expected to have been roughly double that for typical single-break spherical shells,^[c] thus producing recoil forces also approximately double^[g] and requiring a support surface with a correspondingly greater strength.

The not so obvious factor is associated with the design of the three mortar racks. For a ruggedly designed mortar rack, one with substantial support running the length of the rack below the mortars, the recoil force produced by the firing of individual mortars will be delivered somewhat uniformly across the entire area below the rack. In addition, when multiple racks are held tightly together as a single unit, to some extent the load will be further distributed across a wider area below the group of racks. In such a situation, the load strength (in pounds per square foot) of the support surface can be relatively modest. However, in the incident described above, the racks were made of fairly thin and narrow angle iron, with no interconnection between the two pieces of angle iron forming the bottom of the rack except at the two ends of the rack (see again Figure 3). In addi-

tion, the racks were loosely held together in such a way that allowed virtually free vertical movement of the individual racks. One can imagine that these racks will perform reasonably well when positioned vertically on a strong and unyielding support surface. However, such is not the case when the mortars in these racks are fired from a relatively weak and flexible surface.

When racks such as in this incident are fired from a relatively weak and flexible support surface, the recoiling mortars will cause the thin angle iron to twist and spread apart, even to the point of potentially allowing the mortars to slip between the two pieces of angle iron. When that happens, the recoil force from each individual firing mortar is applied to only that relatively small area of the barge deck immediately below the firing mortar. With the full mortar recoil force being applied to such a small area of the barge deck, for the deck to successfully withstand that concentrated force requires that the deck have substantially greater load strength. Then too, once the barge deck begins to fail at one point, the remaining load strength of the barge deck is lessened and the collective individual firings of the other mortars can more easily continue the process of deck failure, ultimately producing a total failure of the deck such as documented in Figure 2.

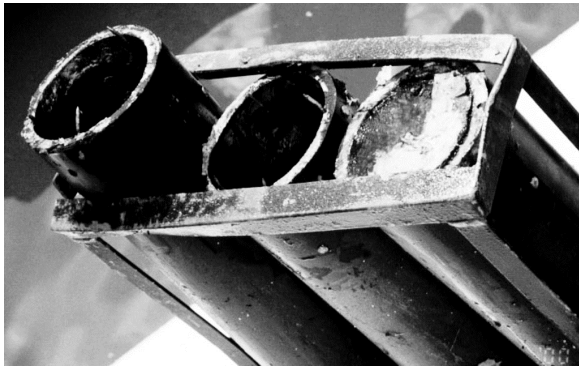
Where the mortar plug attachment in this incident was sufficient for the firing of typical shells in the past, it was not sufficient for the shells on this occasion when fired from the barge deck. It can reasonably be concluded that two factors combined to produce the mortar plug failure, one fairly obvious and one not so obvious. The fairly obvious factor is that the internal mortar pressures for these double-break spherical shells are expected to have been roughly double that for typi-

Figure 3. A photograph of the bottom of one of the mortar racks in which two of the three mortars had completely lost their plugs.

cal single-break spherical shells,^[c] thus requiring a mortar plug attachment strength that was also approximately double.

The length, strength and number of nails securing the mortar plugs used in the incident being discussed, would appear to have been marginally sufficient at best (see again Figure 3). Nonetheless, the mortars had been used many times in the past to successfully fire single-break spherical shells and on occasion double-break spherical shells. If that was the case, why then did the mortar plug attachment fail on the occasion of being fired from the wooden barge deck? It can be surmised that on those past occasions, when the mortar plugs remained attached, the mortars had been placed on much more solid and unyielding support surface than the barge deck (such as illustrated in Figure 4). However, when the shells and mortars were fired on the relatively weak and flexible barge deck, the deck was unable to provide a sufficient upward force on the bottom of the mortar plug to approximately balance the downward force from the lift gas (such as illustrated Figure 5). This resulted in a substantially greater stress on the mortar plug attachment; more stress than it was capable of withstanding. Ac-

cordingly, what had proven sufficiently strong attachment in the past was not sufficient for the relatively weak and flexible barge deck.

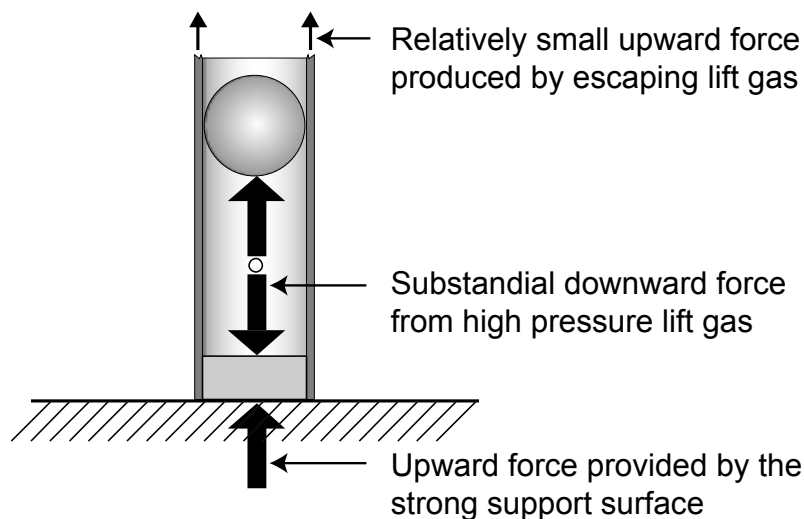
port surface below the mortar plug that approximately balances the downward force on the top of the plug produced by the high pressure lift gas inside the mortar. Figure 4 is an attempt to illustrate this, where it can be seen that the forces acting against the top and bottom of the mortar plug are approximately balanced.^[d] Because of this approximate balance, there will be essentially no tendency for movement of the plug.^[e]

Figure 4. An illustration of the nearly balanced forces acting on the mortar plug that is resting on a very strong and unyielding supporting surface.

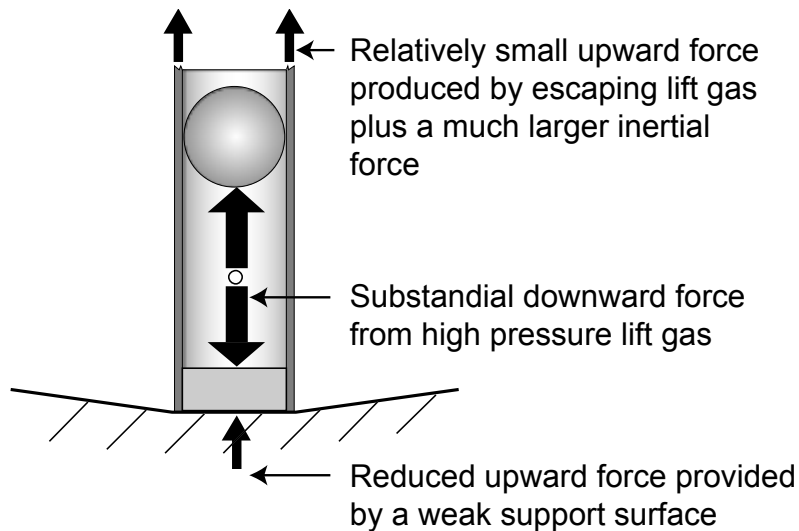
Figure 5. An illustration of the unbalanced forces acting on the mortar plug that is resting on a comparatively weak and flexible supporting surface.

sistance to its sudden downward movement. In this case the attachment of the mortar plug needs to not only counter the relatively small upward force from escaping lift gas trying to lift the mortar up from the plug (as was discussed above), the attachment also needs to be strong enough to counter a much larger inertial force developed due to the sudden downward movement of the mortar tube. Figure 5 is an attempt to illustrate this.
