## The Effect of Reflected Blast Waves in HDPE Mortars

K. L. Kosanke and L. T. Weinman

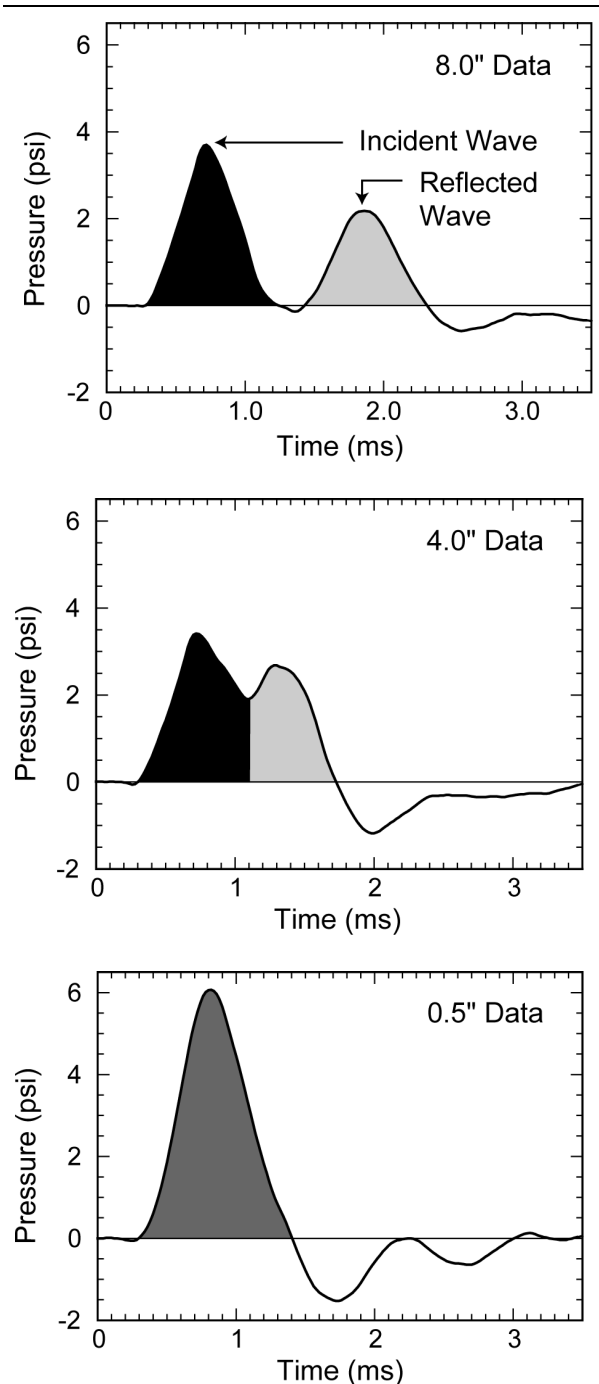
Figure 2. Internal mortar pressure data from the first series of tests.

In the data taken at 8.0 inches above the mortar plug, the incident pressure wave is shown as black and the reflected pressure wave, with its somewhat reduced magnitude, is shown as lightly shaded. The incident and reflected waves are

clearly resolved and are separated in time by approximately 1.14 ms (milliseconds). The pressure wave needed to travel a total of 16.0 inches (8 inches down to the plug and 8 inches back up to the transducer) or 1.33 feet, during the interval between the arrival times at the transducer. At the temperature in the lab, and the initial temperature of the air in the bore of the mortar, the speed of sound would have been approximately 1130 feet per second. This computes to a time interval between incident and reflected pressure waves of slightly less than 1.18 ms, or about 3 percent longer than was measured. That the pressure wave traveled slightly faster than the speed of sound is consistent with its being a weak blast wave. (This was confirmed by examining details of the shape of the pressure event as seen in the raw, non-smoothed, data.)
